## AIRCRAFT ACCIDENT REPORT SUMMARY

Reference:	CA18/2/3/8194	
<b>Aircraft Registration</b>	ZS-JYB	<b>Date of Accident</b>	10 October 2006		<b>Time of Accident</b>	1316Z
<b>Type of Aircraft</b>	Beech Bonanza V35B		<b>Type of Operation</b>		Private	
<b>Pilot-in-command Licence Type</b>		Commercial	<b>Age</b>	44	<b>Licence Valid</b>	Yes
<b>Pilot-in-command Flying Experience</b>		Total Flying Hours	1493.9		Hours on Type	1493.9
<b>Last point of departure</b>		Cato Ridge Aerodrome				
<b>Next point of intended landing</b>		New Tempe Aerodrome				
<b>Location of the accident site with reference to easily defined geographical points (GPS readings if possible)</b>						
Drakensberg mountain in Underberg area at altitude of approximately 8878 ft at GPS position: S29° 40' 00" E029° 10" 00'						
<b>Meteorological Information</b>		Temperature 4°C. Wind: 090° / 4kts. Cloud: 8 Oktas. Cloud base: 500 feet AGL				
<b>Number of people on board</b>	1 + 2	<b>No. of people injured</b>	0	<b>No. of people killed</b>	1 + 2

## AIRCRAFT ACCIDENT REPORT

**Name of Owner/Operator** : R H Glemius  
**Manufacturer** : Beech  
**Model** : V35B  
**Nationality** : South African  
**Registration Marks** : ZS-JY

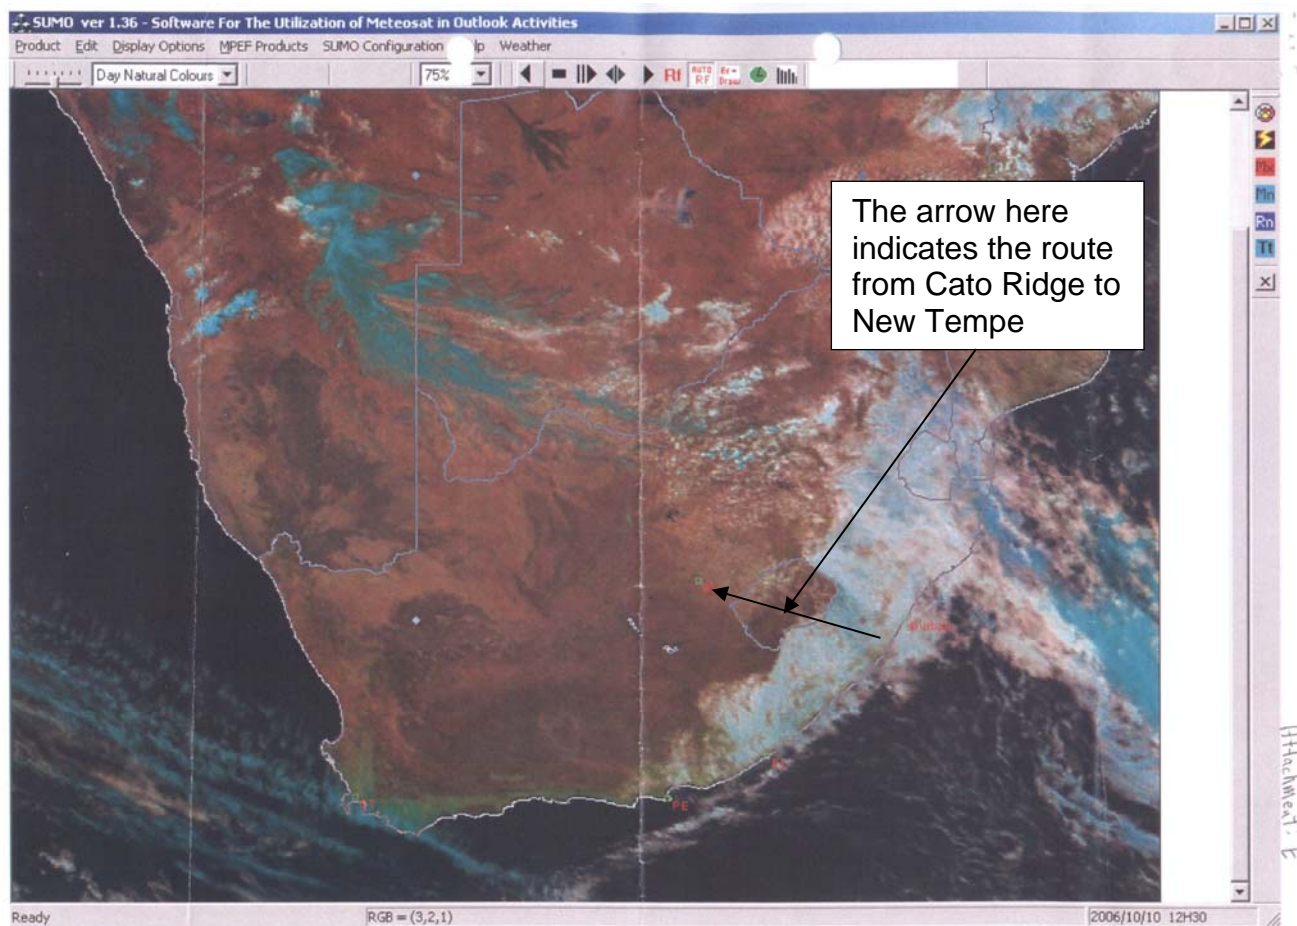
One can observe from the image above and the track inserted that the area to the East of the Drakensberg where the accident scene was, was covered with cloud to approximately the same altitude as the mountain tops.

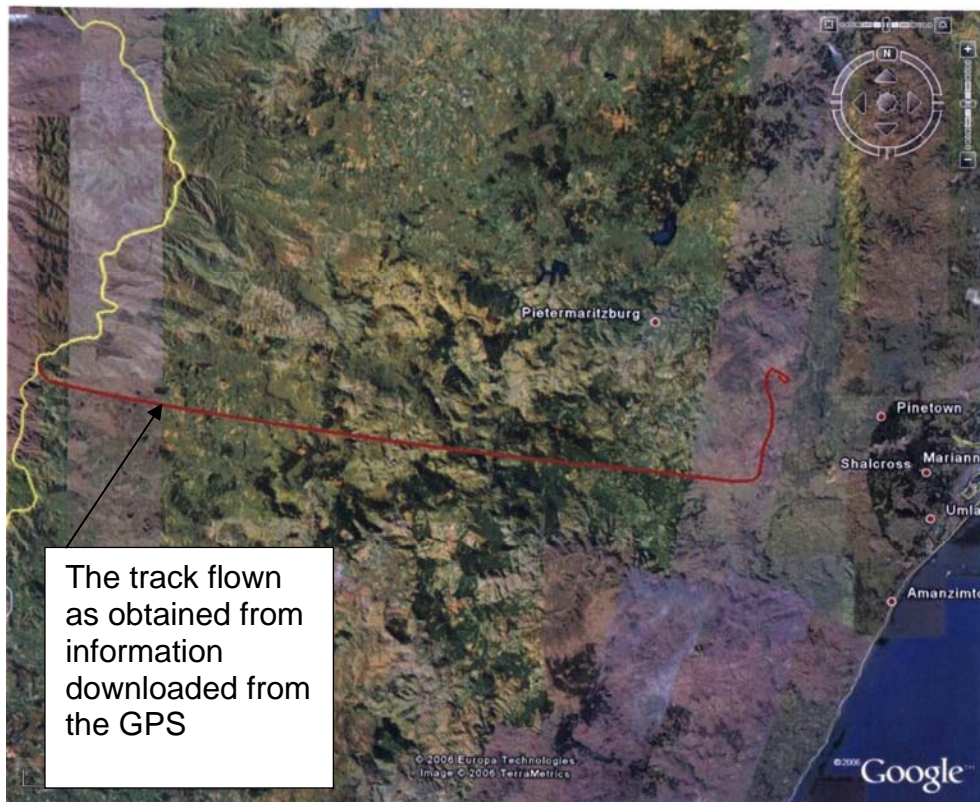
1.11.2 During the on-site investigation, a Garmin 296 GPS was recovered in the vicinity of the main wreckage. The GPS was forwarded to the French Bureau Encartes (BEA) to download any recorded track information that might be available on the non-volatile memory of the unit. The BEA was able to download the aircraft’s track from take-off to impact. The following picture is a depiction of the aircraft’s track superimposed onto the area map obtained from the Google Earth database:

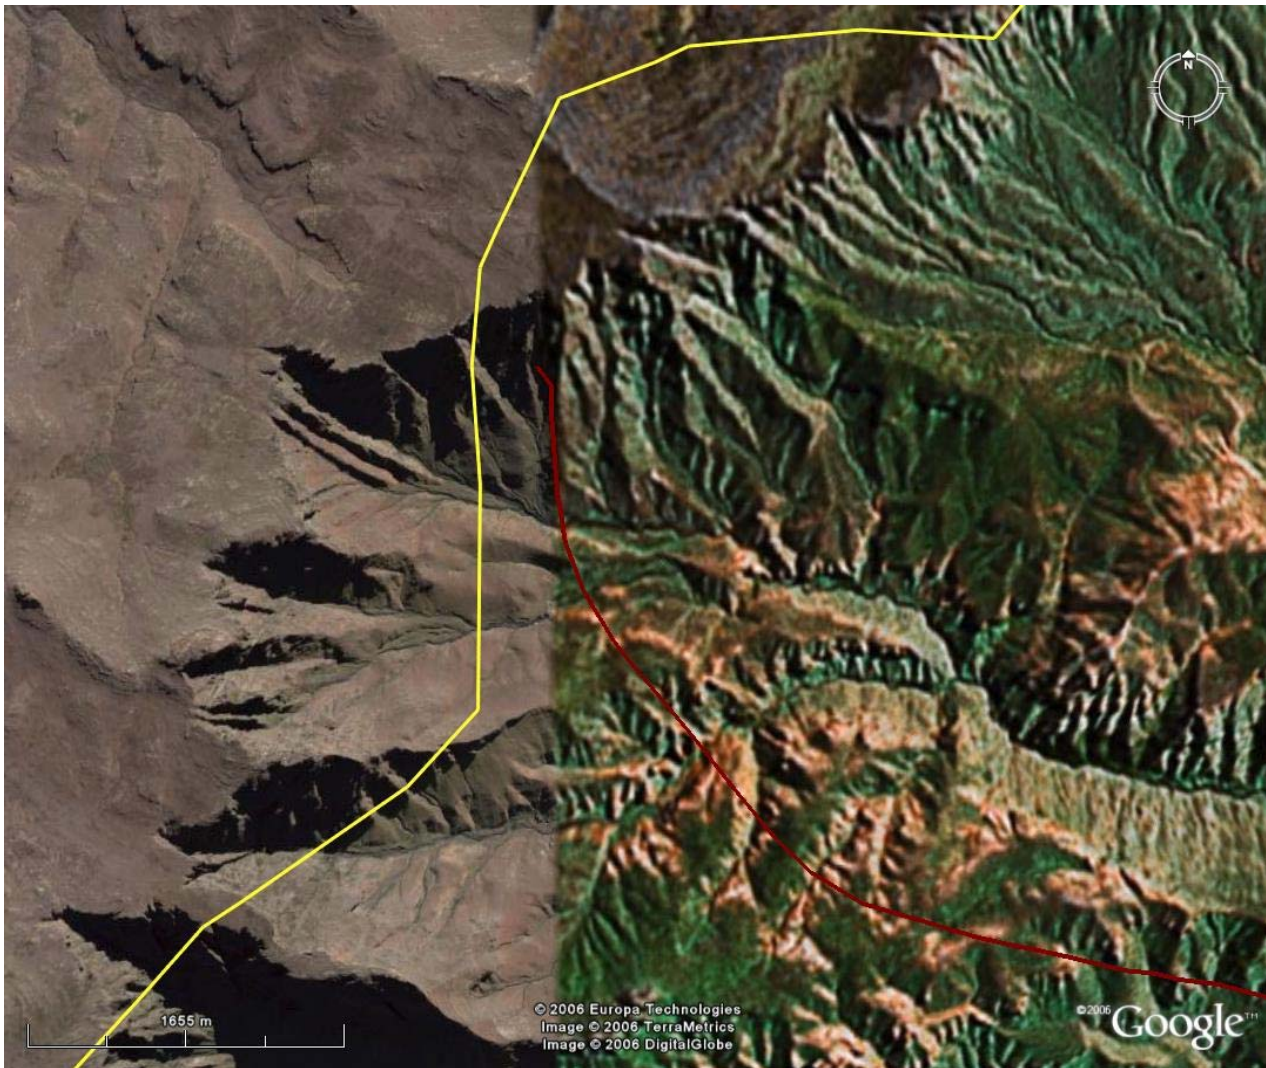
From the above picture it can be observed that the aircraft made a turn to the right in the last part of the flight and in the last four seconds of the flight entered a left climbing turn to the point of impact.

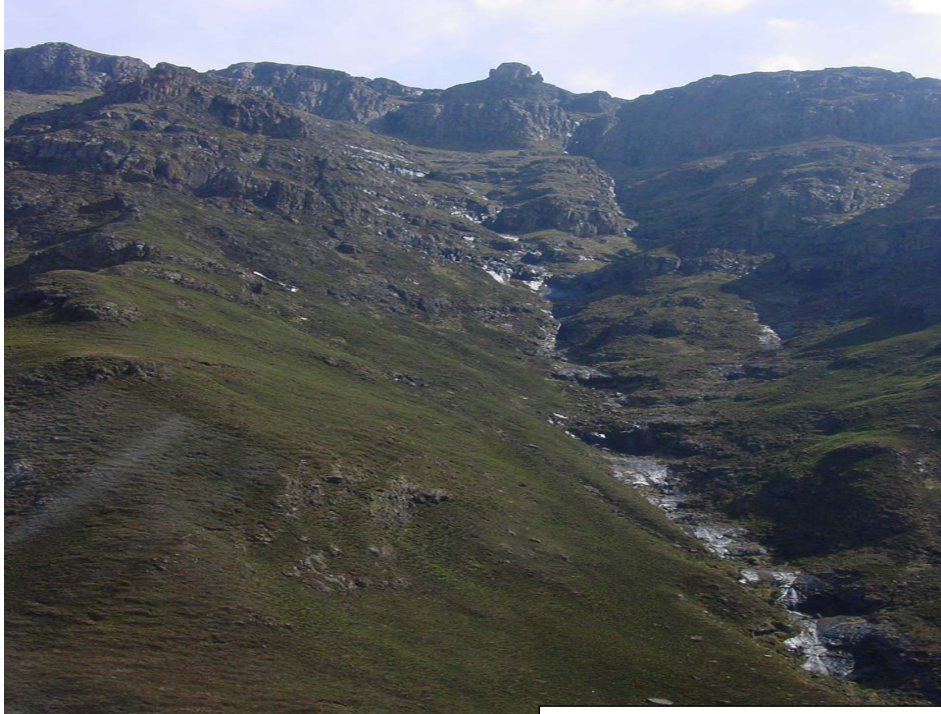
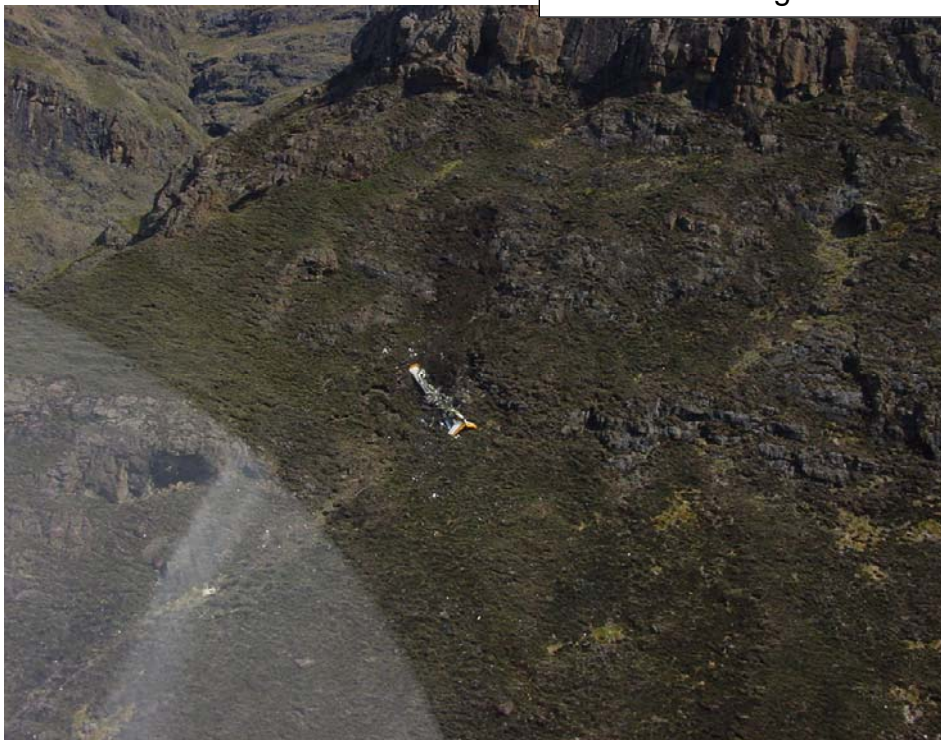
- 1.12.1 According to the GPS-information, the aircraft impacted the terrain at an altitude of 8957 ft (2707m) whilst in a climbing turn and with a reduction in groundspeed.
- 1.12.2 Impact occurred on the southern ridge of a valley with raising ground which offered no escape or turn-around options for the pilot.
- 1.12.3 It could not be determined whether impact occurred within IMC or VMC conditions.
- 1.12.4 Impact occurred with a lower-than-cruising airspeed whilst climbing, implying that the pilot was attempting to avoid raising terrain.

These images show the position of the wreckage and surrounding terrain

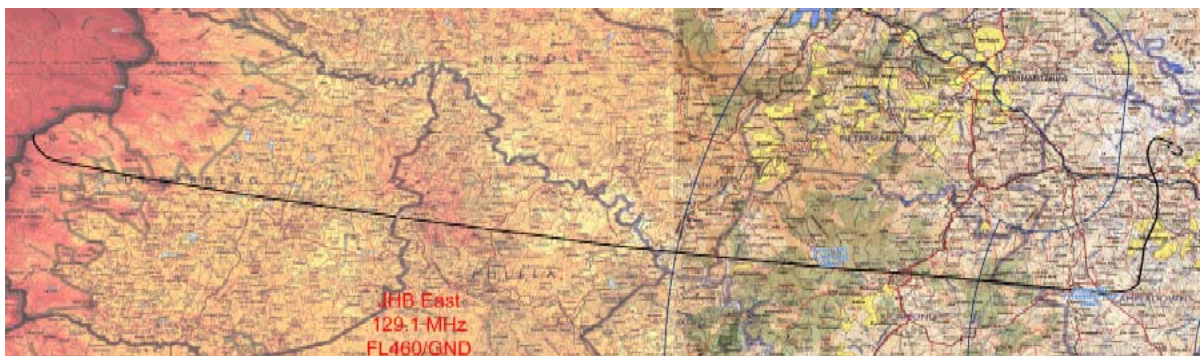
After becoming airborne, ZS JYB joined the FADN TMA at 1032Z and was vectored to remain clear of the FAPM CTA due to other IF-traffic. This airspace is classified as Class G – airspace in which IFR-flights and VFR-flights are permitted and all such flights receive flight information services, if requested. The aircraft was subsequently cleared to climb to FL080 and to proceed directly to the destination and was handed over to Johannesburg-East Air Traffic Control Centre. Again the clearance was to proceed directly and to call again at Maseru TMA. Refer extract below from the applicable aeronautical maps with ground track imposed.

It is the responsibility of the pilot-in-command to plan the flight to ensure adequate separation with the terrain. Reviewal of the applicable aeronautical maps would have indicated to the pilot that the minimum safe altitude for the route would at least have to have been 12 700 ft agl. Selection of a flight level of 8000 ft would not have ensured adequate terrain clearance on the selected route, i.e. Cato Ridge direct New Tempe.
